TECHNICAL INSPECTION REPORT

(6) OPERATION CROSSROADS.
U.S.S. ARDC 13.

TEST BAKER [U].

USS ARDC 13

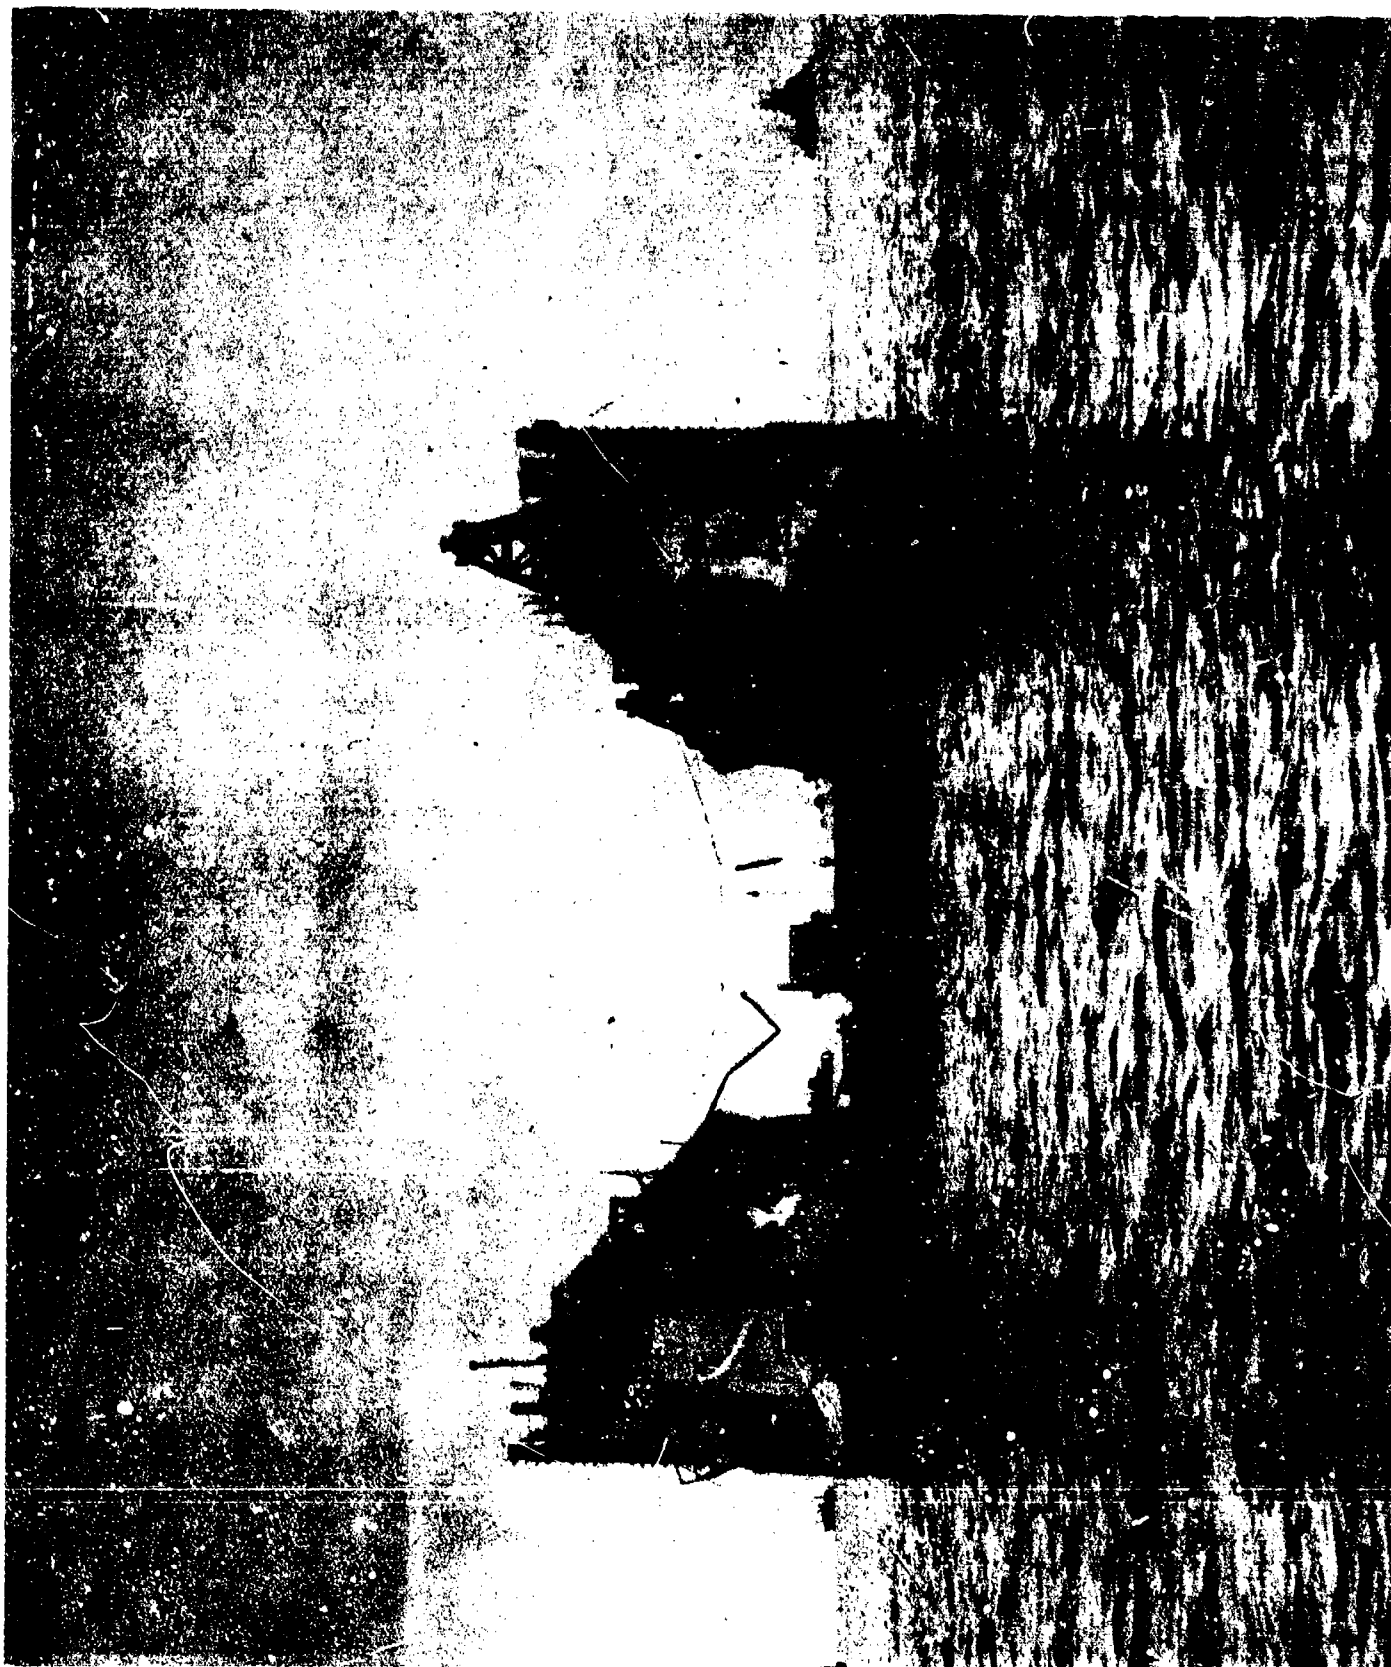
AB-CR-227-289-114. View from ahead after Test B.

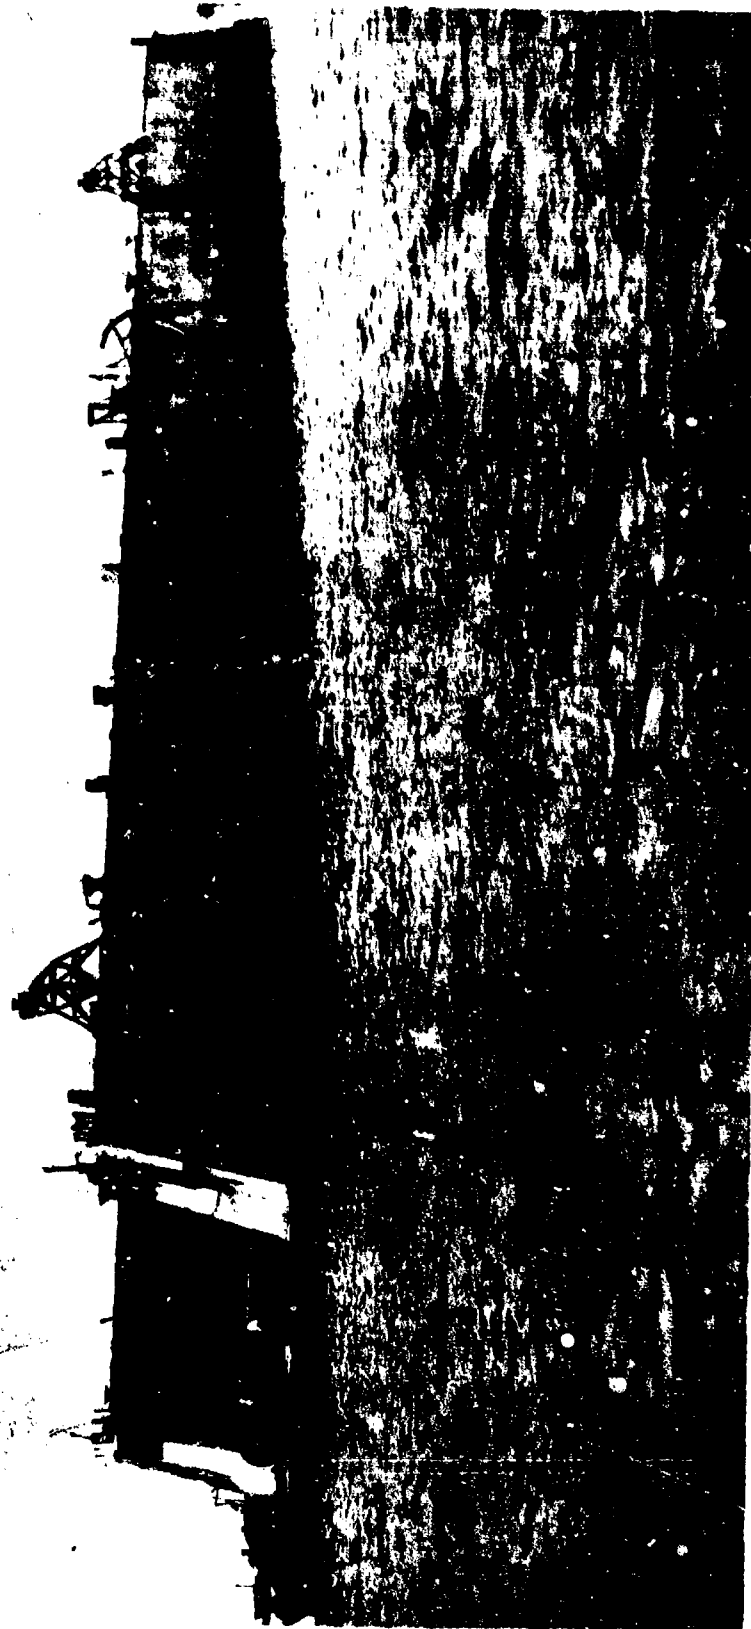
AB-CR-227-289-115. View from off port bow after Test B.

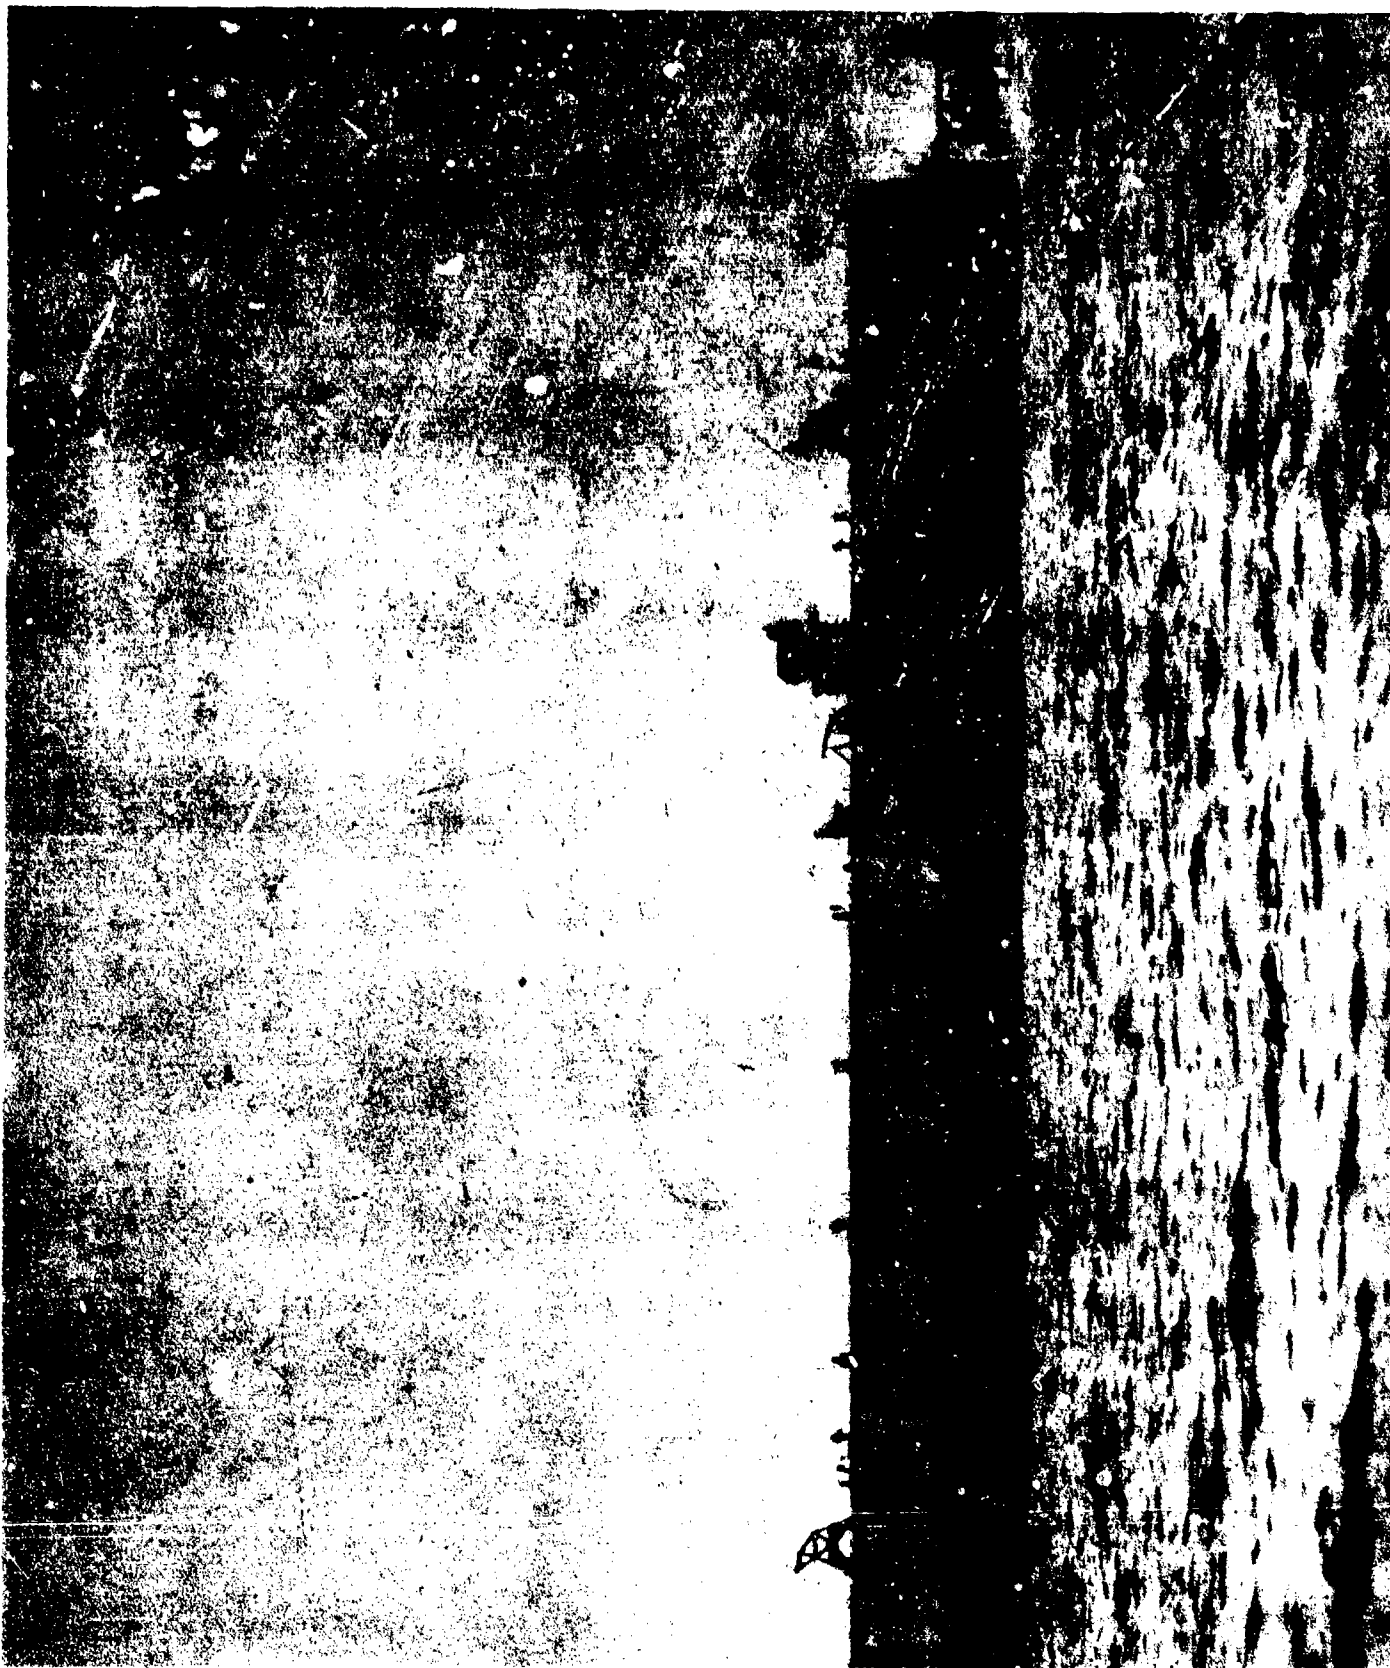
BB-CR-227-519-114. View from off port beam before Test B.

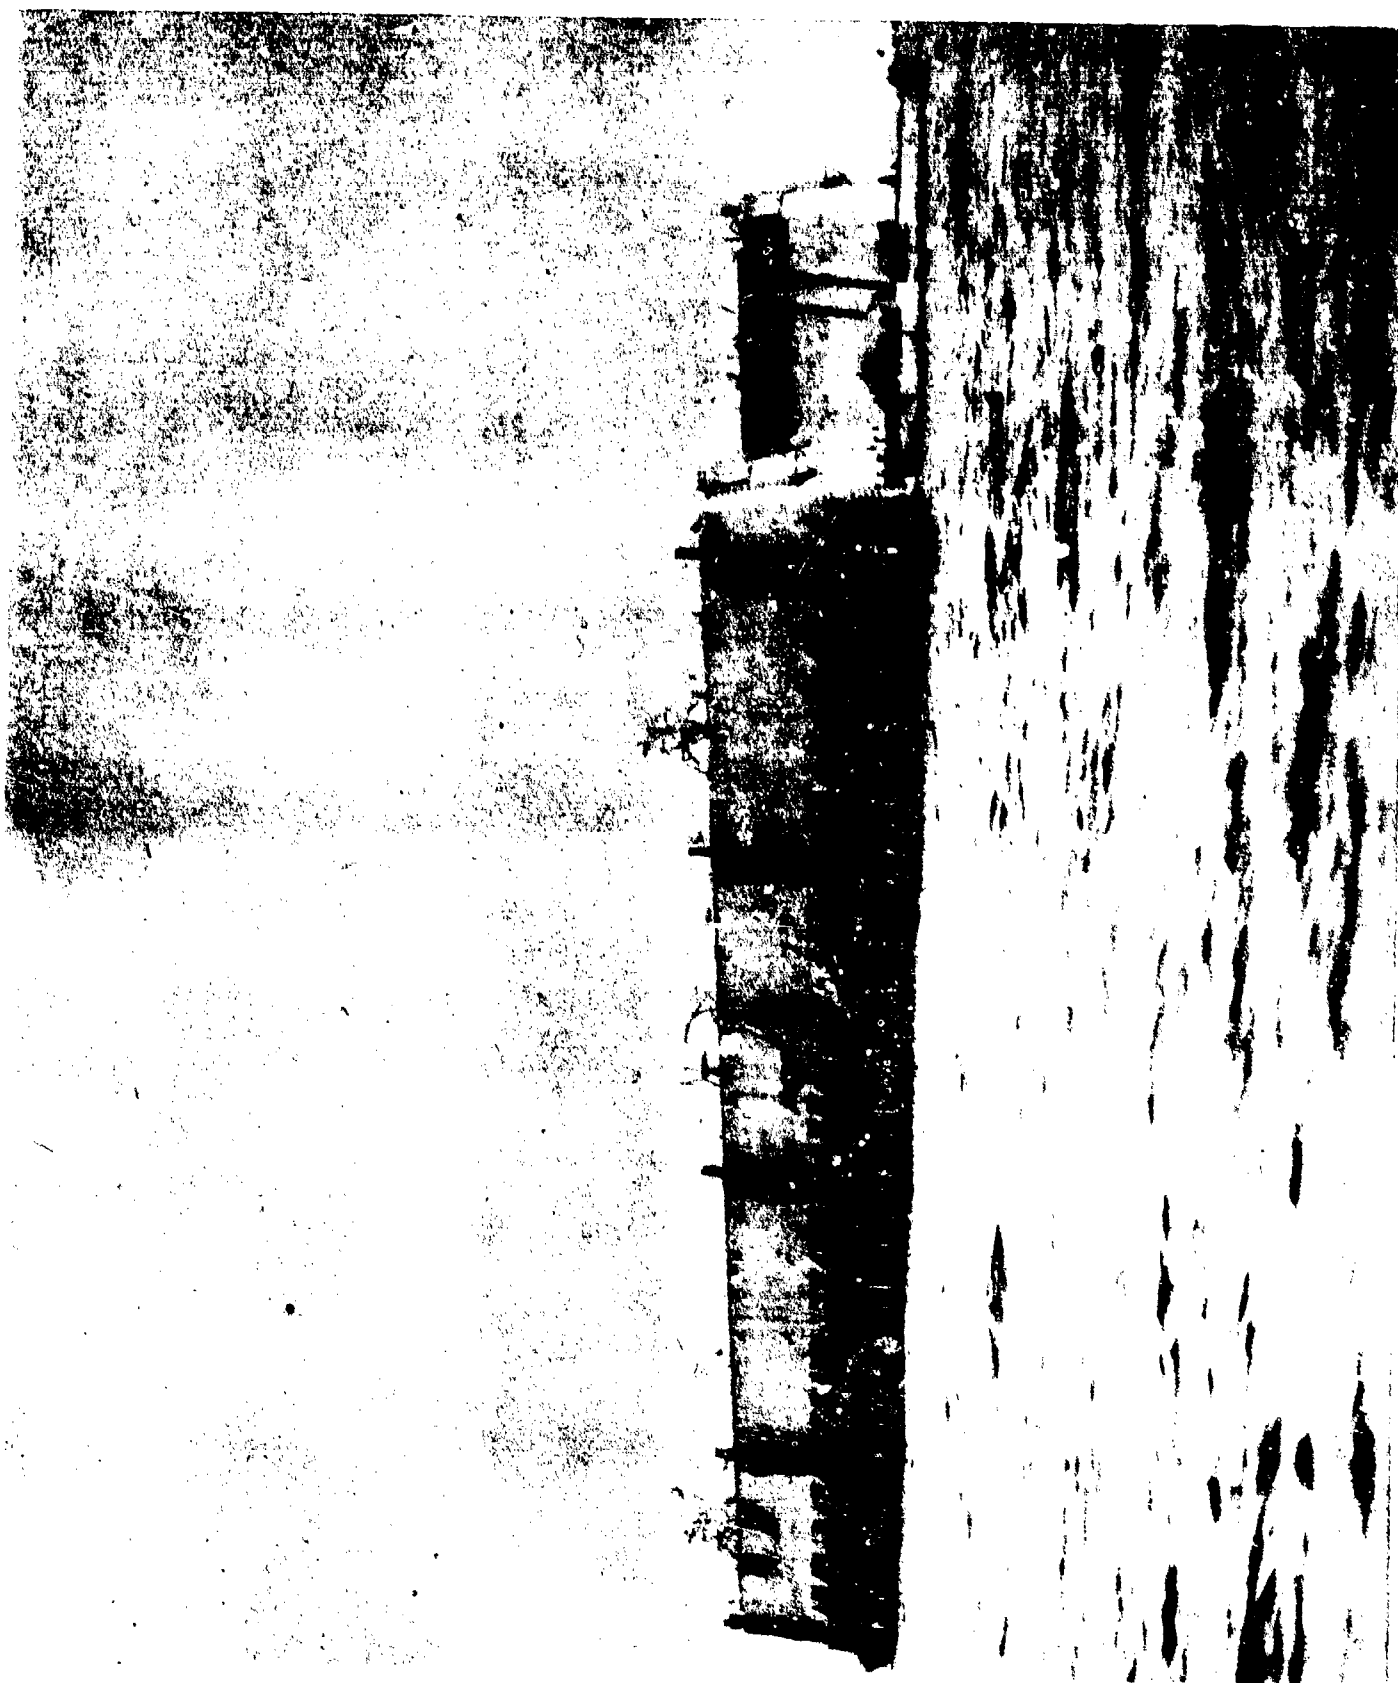
BB-CR-227-519-115. View from off port quarter before Test B.

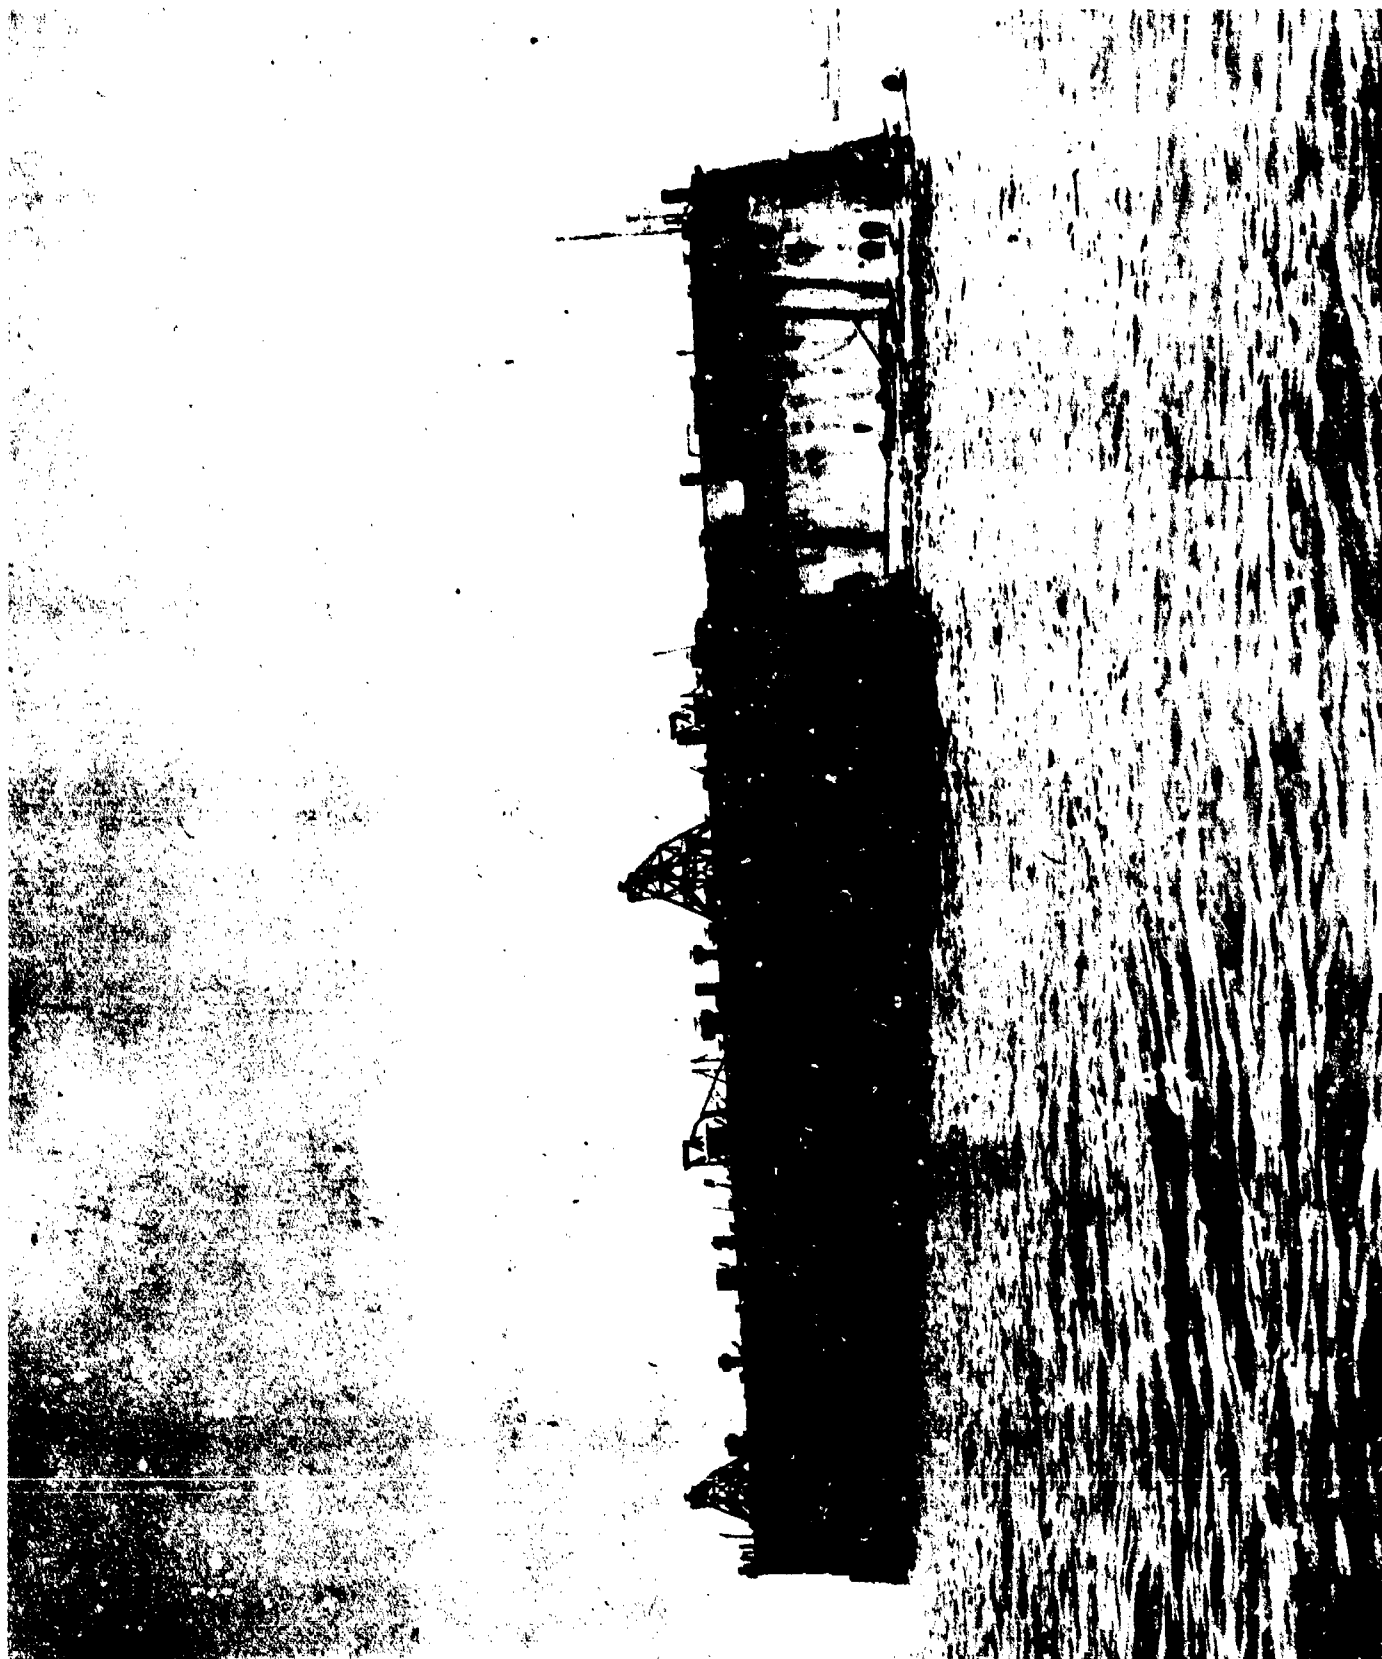
AB-CR-227-289-117. View from off port quarter after Test B.

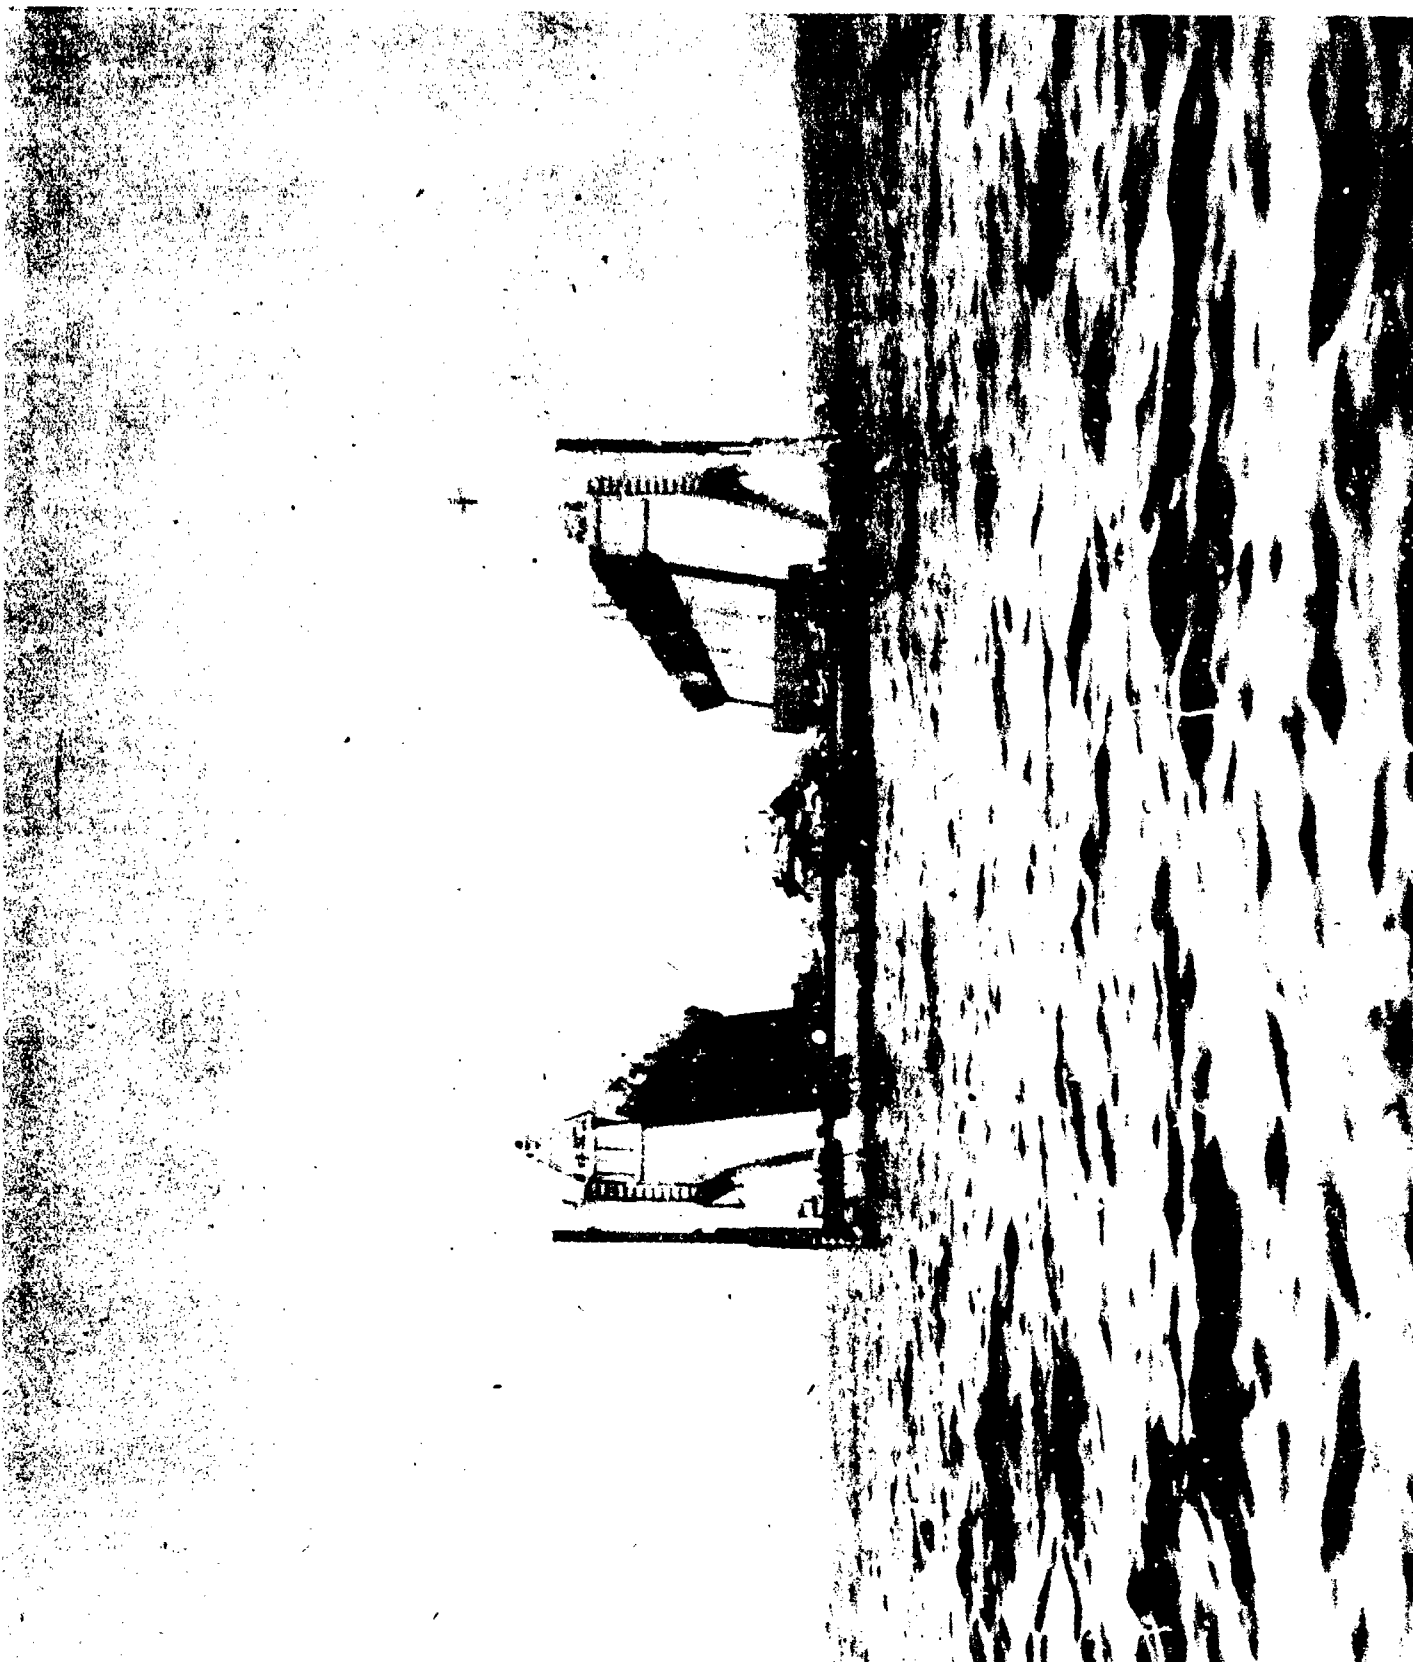
BB-CR-227-519-116. View from astern before Test B.

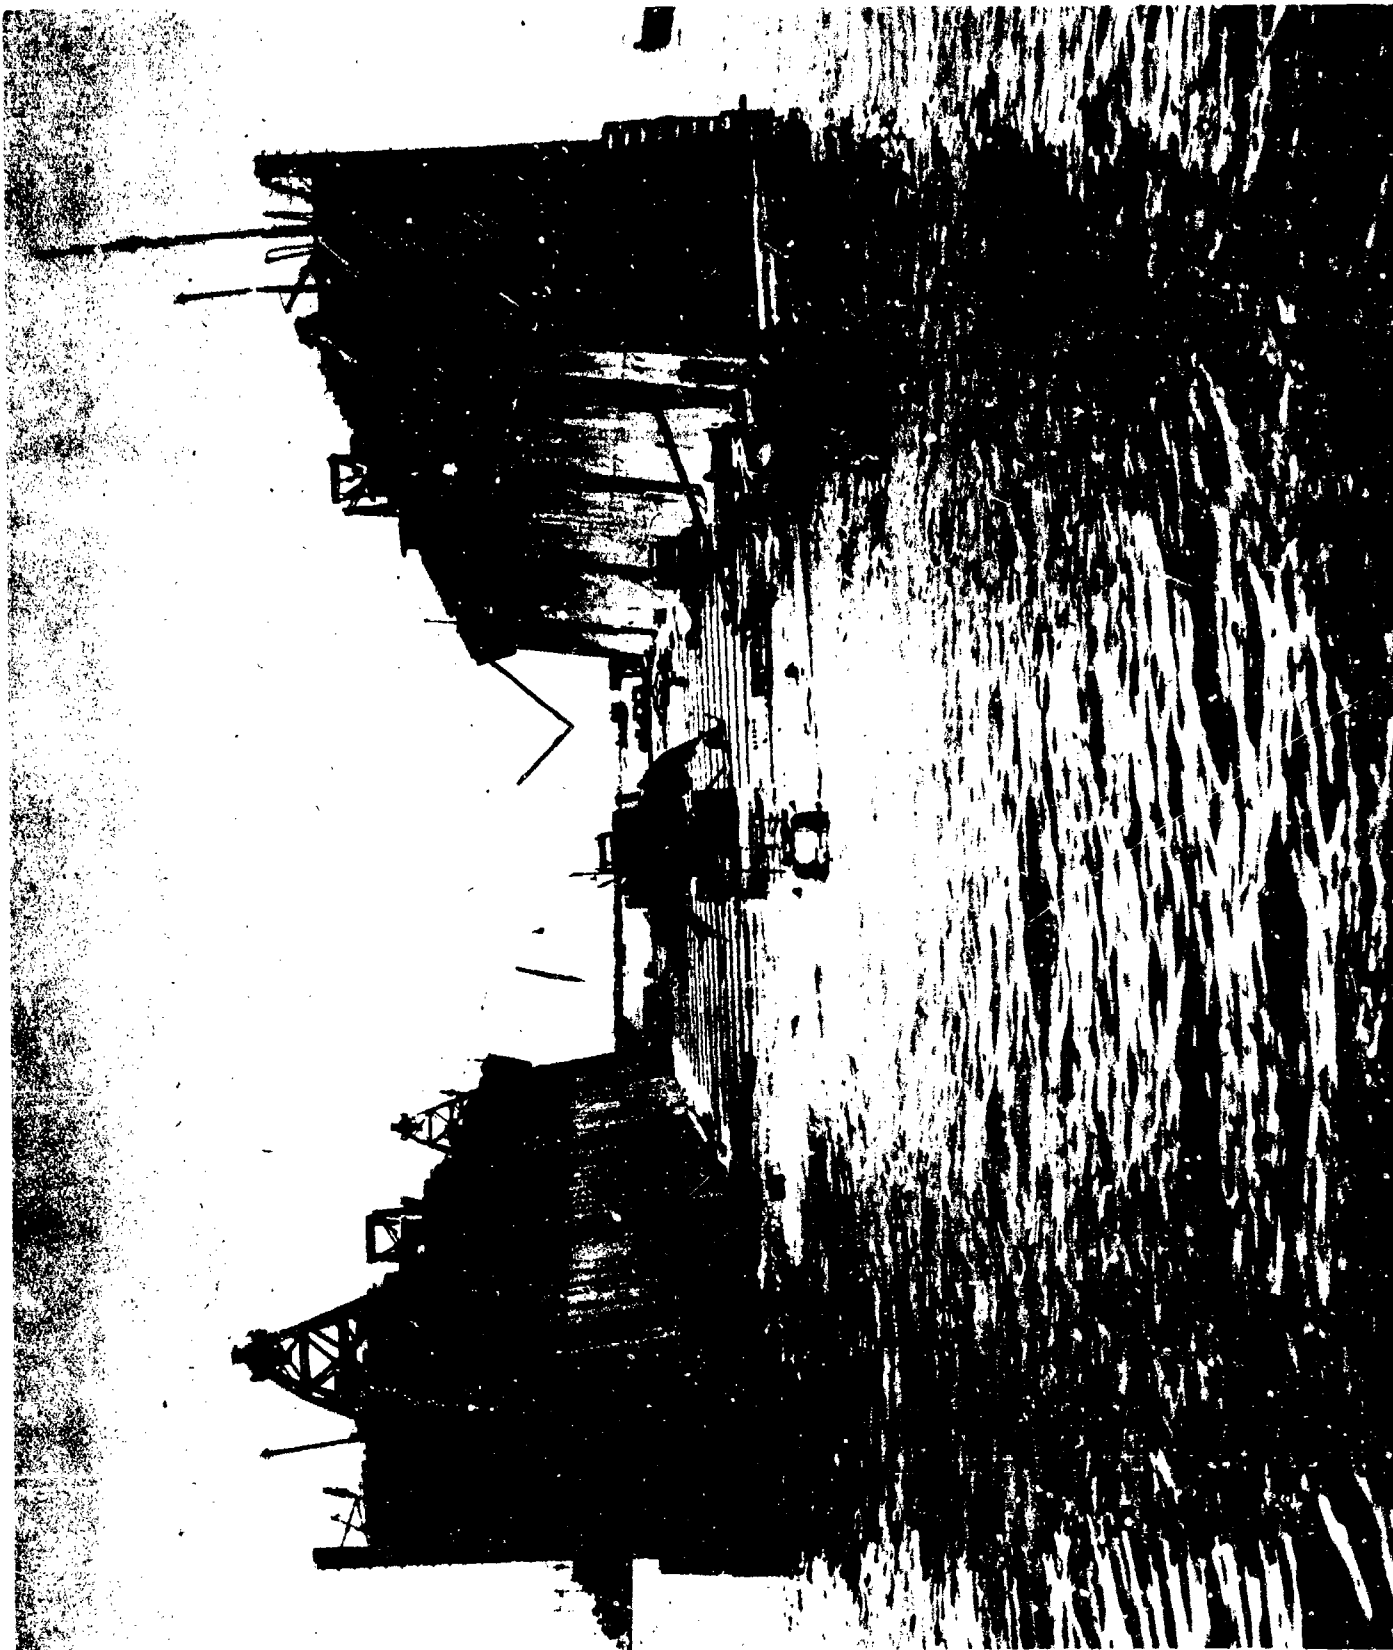
AB-CR-237-289-118. View from astern after Test B.

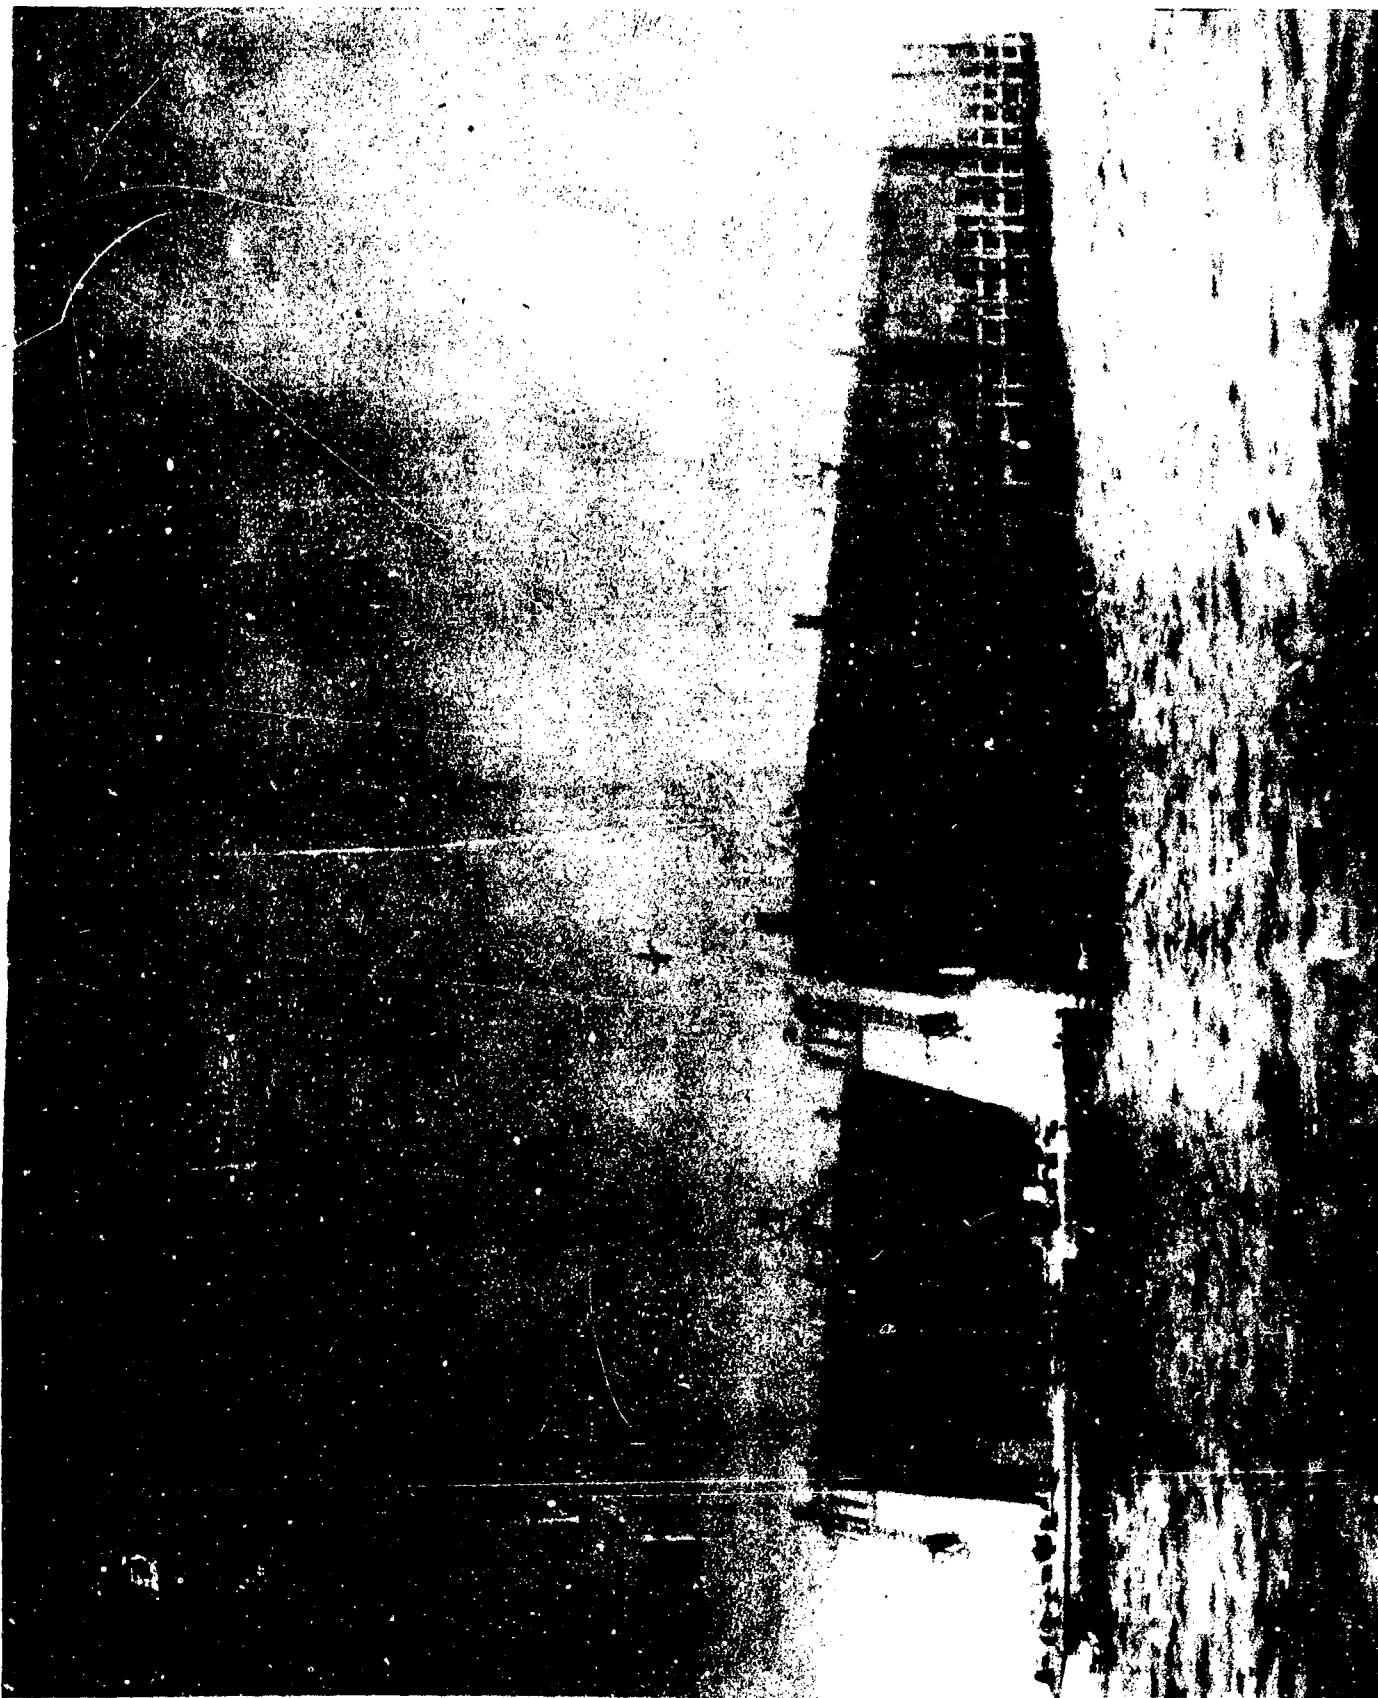
BB-CR-227-519-117. View from off starboard quarter before Test B.
